Structure	Canal	HAER/CEHR
>			Condition
Inventory	State/ Province County	Designer:	
It	City/Town	Contractor:	
er	Street	Source of Material:	
ž	Associated Waterway	DATES OF CO	DNSTRUCTION
Ч	Topographic Map	Start:	Rebuilding:
IL	UTM Coordinates	Completion:	Abandoned:
<b>Canal Structure</b>	History & Use in Service (use since Abandonment):		
0			
2			
S			
al			
() ()			
U			
>			
Society	Description (Visible Remains at Site):		
Si€			
ŏ			
Š			
Ja			
ar			
American Canal			
ar			
ö			
Ľ			
Je			
L			
◄			
	Other works or events associated with site:		
	Present Property Owners:	Location of Deed Description:	
	Bibliography, Published, unpublished, maps, photographs		
	Agencies, Interested	National Register, Other Recognition:	
	Investigation made by:		Date:
	Address:

Google Earth view of Eureka Lock & Dam Cross Florida Barge Canal

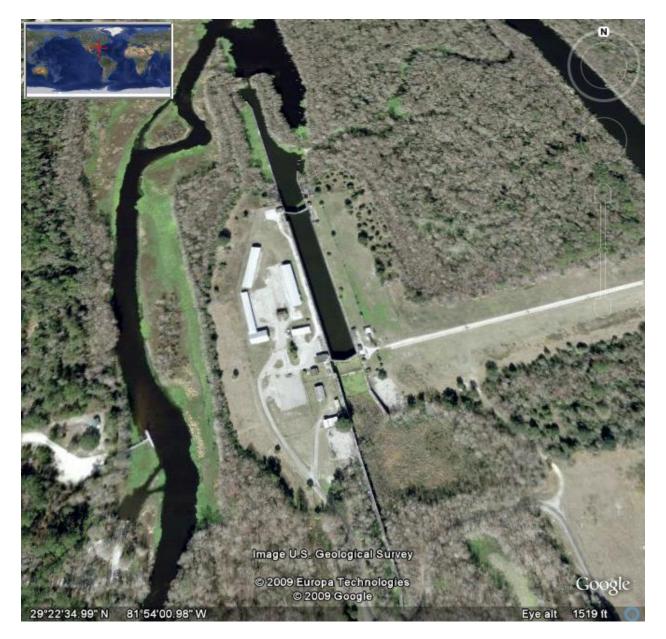
Lock is complete and watered. Dam is complete to the right of the lock. Only the small piece of dam across the river to the left of the grass to the white "T" structure is missing.

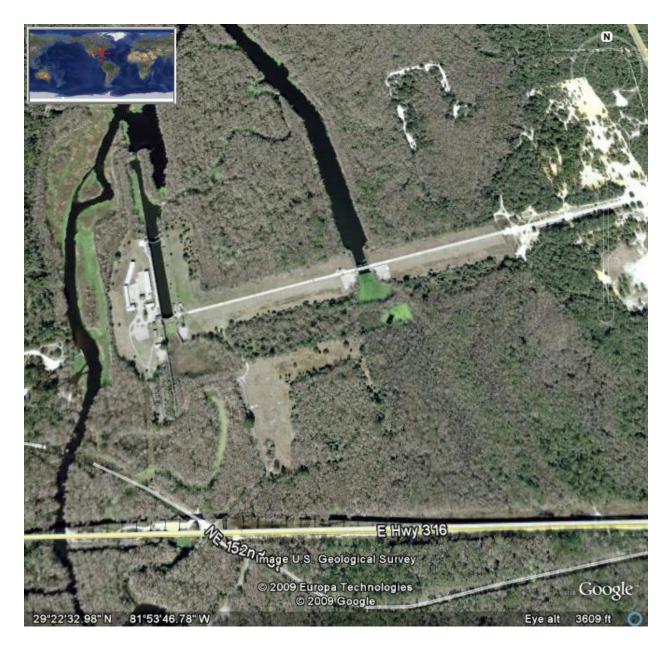
Higher Google Earth view of Eureka Lock & Dam Cross Florida Barge Canal Showing lock, entire dam, spillway, and SR 316 bridge
